REMOVING CFA AUGER SECTIONS

Overview

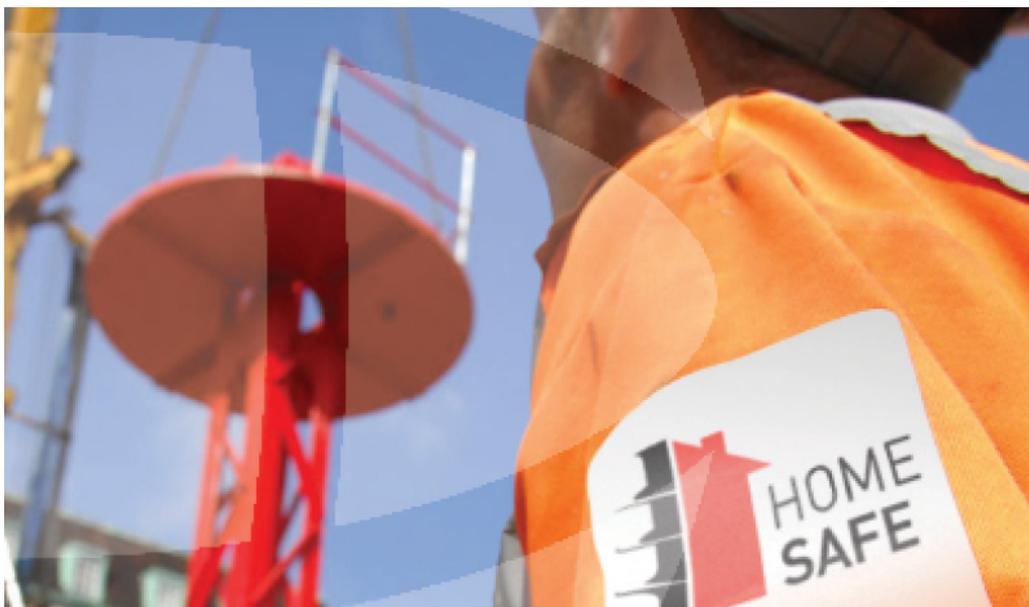
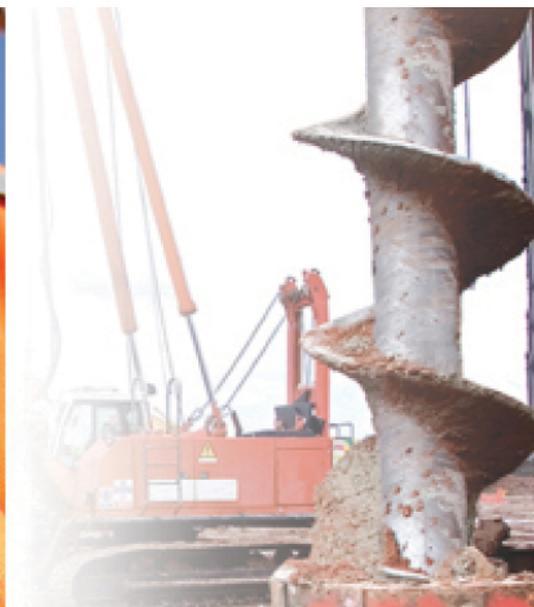
A recent incident occurred on a BSL site which resulted in the Kelly bar of a CFA auger string becoming disengaged from the rotary. The rotary and string of augers were high up the mast at the time of the incident.

As a result of the disengagement, the auger string and Kelly bar came down and hit the top of the rotary. This caused the end flange of the Kelly bar to shear off. The Kelly bar then continued to travel through and out of the rotary until the bottom section of auger came into contact with the ground and buried itself a short distance, leaving the Kelly bar and auger string unsupported.

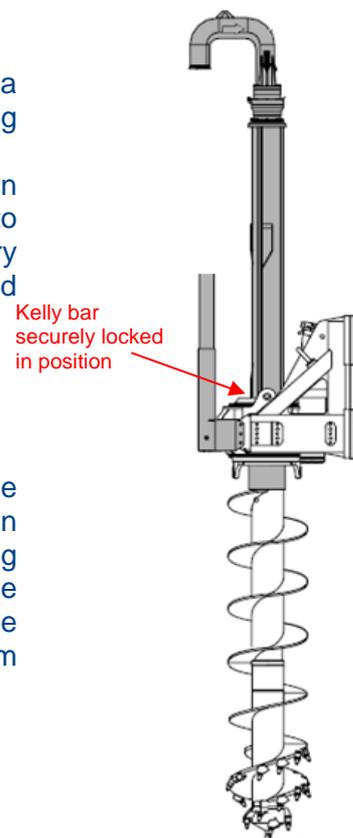
The rotary was brought down to rest on top of the Kelly bar to secure the auger string until the service crane could be attached to remove it safely. The drilling rig was inspected for any damage, which included the mast head and rope sheaves. A new rope was ordered due to the shock load that had been applied to it. The rotary was returned to the workshops for a thorough internal inspection. The damaged Kelly bar and flange were also returned to the workshops for inspection and assessment for repair.
