Daily Maintenance of B-Type Blocks

BACKGROUND

There has recently been a near miss with two B-Type blocks falling 24 metres from the auger string.

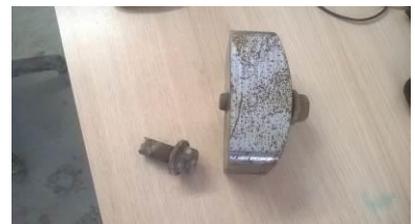
The male and female B-Type coupling arrangement is designed to ensure the securing blocks carry all of the forces while drilling and extracting the auger during the pile construction. The securing bolts are employed to ensure the securing blocks are positioned correctly and seated on the male coupling. The investigation into the securing bolts failure and consequently the securing blocks coming out of their seating within the couplings, found that there was +20mm of thread still left protruding out of the male coupling.

This finding determines that the blocks were not tightly secured within their seating and the securing bolts in this case were loaded with the mentioned drilling forces. As the bolts are not intended to carry the high shear forces between the male and female coupling, they failed and the securing blocks fell out.

- The rig operator must ensure that the auger coupling's securing bolts have been tightened correctly on a daily basis.
- The bolts should be checked from ground level as the auger is drilled into to the ground.

- The securing bolts are to be torque tightened DRY to a value of 175 NM with a suitable socket and wrench. If the bolt is unable to be tightened fully, this could indicate that there is an issue with the securing bolts or the male coupling threads.

- The auger section must not be used unless all three securing blocks are correctly fitted and secured in place.
