# HGV Coupling Failures

## High Potential (Hi-Po) Incidents

**SAFETY ALERT**

Number: 107  
Date: 26/07/2018

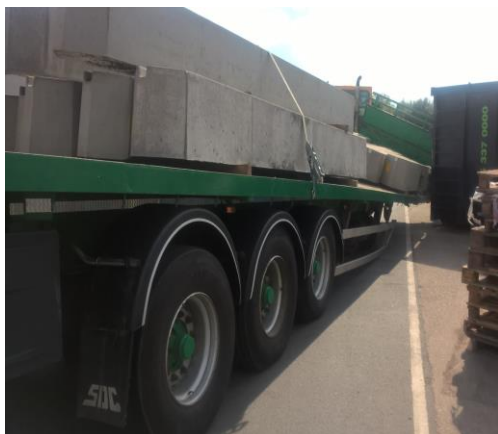
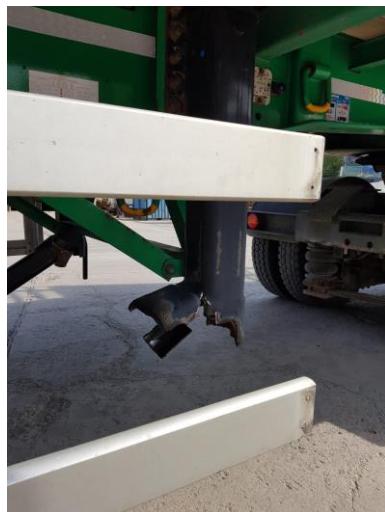
Images above from 16/07/2018

On Monday 16/07/2018 & Wednesday 18/07/2018  
Two HiPo incidents were reported. Both incidents involved  
trailers becoming detached from the HGV units pulling them.  
In both Incidents significant damage was caused to the  
trailers, both of which were loaded at the time.

Both incidents were caused due to the trailers not  
being coupled properly and visual checks of the 5<sup>th</sup>  
wheel assembly not being conducted prior to moving  
the trailers.

- Exclusion zone implemented
- Product removed and trailers recovered.
- Full investigation being conducted by the SHEQ and  
Transport departments.

- Please ensure that the 5<sup>th</sup> wheel assembly is  
checked and engaged properly prior to  
moving any trailer.
- If any defects are found or if in any doubt at all  
please **STOP** and inform the Transport  
department.
