Unloading Steel Tube

High Potential (Hi-Po) Near Miss

SAFETY ALERT

Number: 103
Date: 21/06/2018

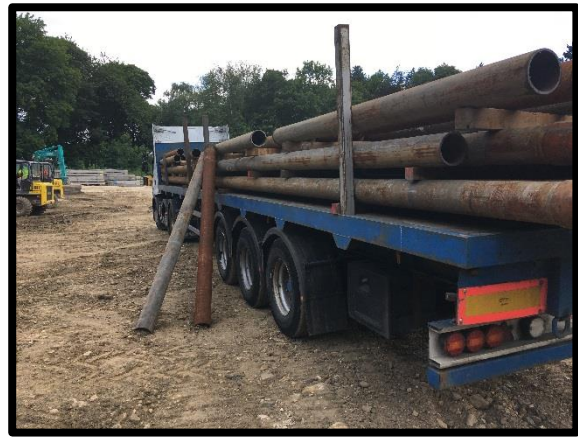
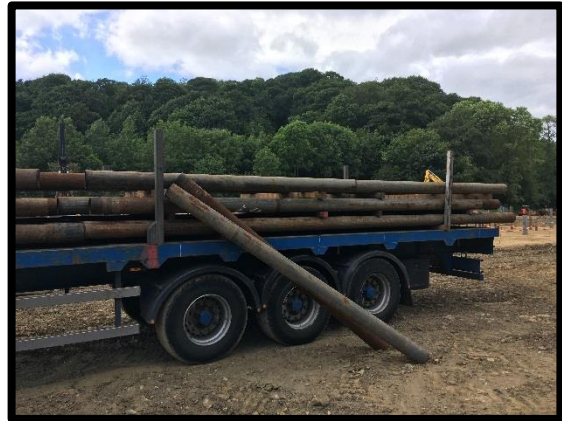
During the unloading of a steel tube delivery from Steel Tube Supplies (STS), two 3m tubes (situated behind the 6m lengths) rolled forward and came off the vehicle bed. The vehicle goal posts had been set up for 6m lengths.

- Supplier error in the way the load was presented (3m lengths behind 6m lengths, site team not informed by the driver).
- Vehicle goal posts had not been set out to protect the 3m lengths from rolling off the bed.

- Load made safe and unloaded.
- Supplier informed, awaiting response on actions to prevent reoccurrence.

- When an exclusion zone is implemented and maintained, the likelihood of a person being harmed by this type of incident is reduced massively.
- Please ensure that an exclusion zone is set up, implemented and maintained when carrying out any unloading process.

- RB will look to work with the supply chain to identify any possible ways to improve the way steel tube loads are presented.
