# Concrete Boom Pump Arm Failure – CIFA K39H - Carbotech

High Potential (Hi-Po) Near Miss

**SAFETY ALERT**

Number: 105  
Date: 11/07/2018

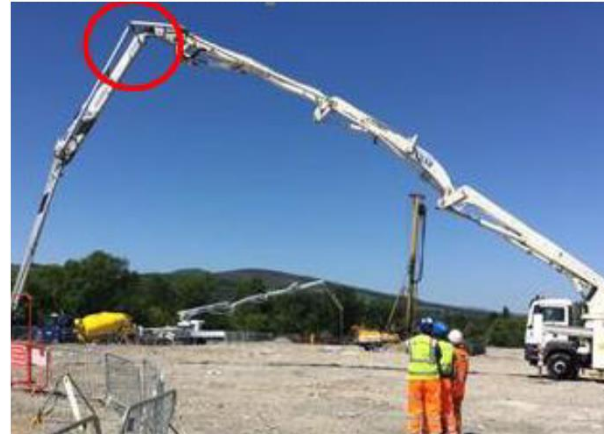
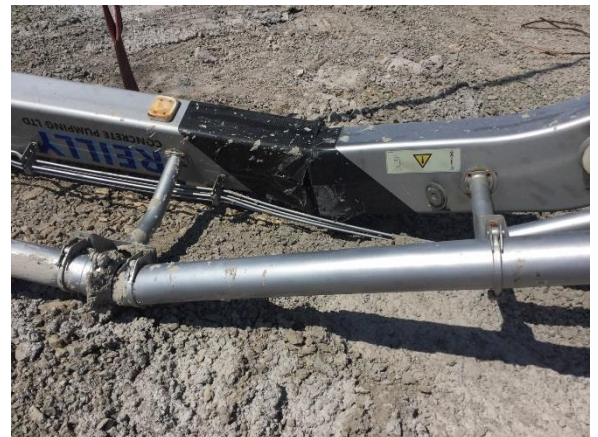
Whilst rig 7006 was manoeuvring, the rubber hoses (flex) connecting the rig to the concrete boom pump (K39H Carbotech) stretched causing a section of the boom arm of the pump to fail.

- “ Hydraulic pipe damage
- “ Steel hose spilt

- “ Concrete boom was at full stretch
- “ Slewing manoeuvre of rig caused flexible hose to stretch
- “ Connections between sections 3 & 4 was carbon fibre to steel

- “ All works stopped, area made safe and exclusion zone implemented around concrete boom pump.
- “ Dynamic risk assessment carried out to pump out concrete and recover equipment
- “ All RB Areas instructed to not use concrete boom pumps with carbon fibre arms until further notice

- “ Clear communication between the Concrete Pump Operator (CPO) and the Rig Foreman must be established.
- “ CPO and Rig Foreman should discuss and agree the maximum radius that the boom will operate.
- “ Radio communication is being trialled between rig foreman and CPOs within Dumbarton project.
- “ A review is being undertaken of current procedures to develop a standardised communication process between Piling operatives and CPOs when slewing.
