Wire Lifting Loop Failure, 850 x 850 HD Cap

High Potential (Hi-Po) Near Miss

SAFETY ALERT

Number: 104
Date: 27/06/2018

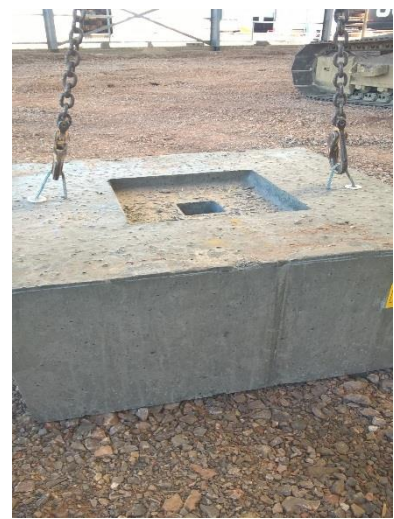
Example of the cap being lifted

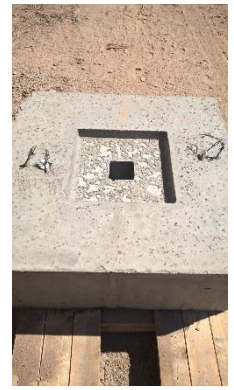
- Damaged/ worn wire lifting loop prior to lifting.

Example of damaged wire lifting loops

- Please ensure **ALL** lifting loop wire ropes are inspected for defects prior to lifting.

Ensure that any damaged wire lifting loops on products are not used and reported back to SHEQ/ Production.
