Incident Report

Service Strike – 18.10.18

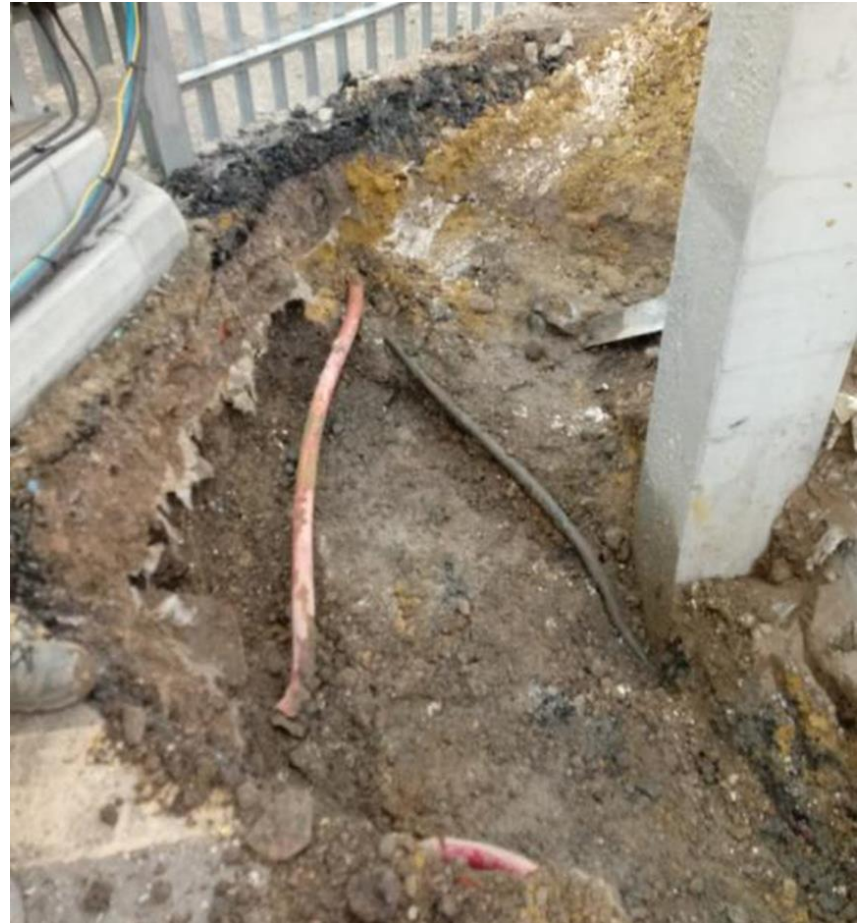
- An 11Kv underground cable was struck during an operation to drive a precast concrete pile.

- The site crew were instructed to replace a pile. During the installation of the new pile, the power went off in the business estate. The site crew immediately stopped works and the Electricity Provider were informed. However the initial report from the supplier was that this was only a power cut and so the site crew were instructed, by the principal contractor, to continue works.
- Five days later, the site crew were informed that the replacement pile had damaged an 11Kv cable 300mm below the piling mat.
- Permits confirmed that a full site scan had been completed and services were not marked as present.
- Further utilities were subsequently discovered and the PC is now proof digging all remaining pile positions

- An investigation has commenced into the competence and detail of the utility investigation. This incident highlights the importance of ensuring that thorough investigation and scanning for buried services is completed prior to acceptance of the permit to break ground.
