## ***SAFETY ALERT***

Rig Overturn

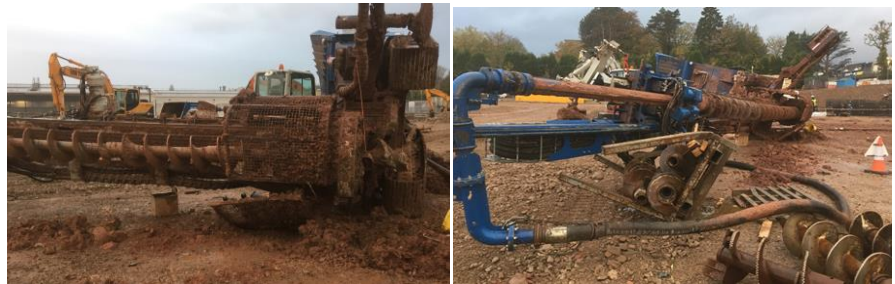
A Hired MC13 Rig had set up over a pile position and drilled approximately 500mm to enable the mast foot to be lowered, during the set-up process the rig over-turned.

- Instability of the rig was the immediate cause of the overturn.
- Ground conditions were solid and firm.
- Rig stabilisers were not deployed by the operator.
- Mast foot was not grounded due to the length of the auger string.

- Lack of familiarisation and understanding of the safety critical functions of the equipment by the operator.
- Management failure to carry out familiarisation regarding safety critical features of hired-in equipment.
- Plant Hire handover process insufficient.

Reviewed and amended internal familiarisation and training processes in relation to plant and equipment.

In relation to familiarisation awareness of hired-in equipment management briefings have taken place with regards to new operators training in relation to new starters and hired-in plant in order that the safety critical features of the plant have been briefed, documented and recorded.
