HI-POTENTIAL NEAR MISS FALL HAZARD FROM AN OPEN BORE HOLE

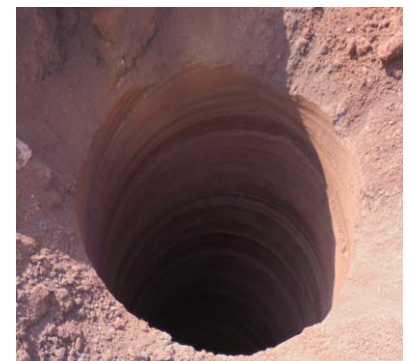
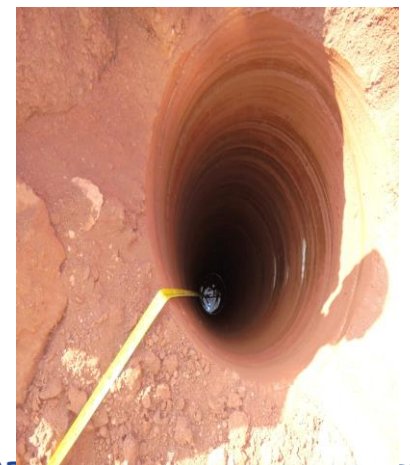
It was reported that due to a change in the design regarding the position of the crane base piles there was delay in the installation of the piles. Because of this change, the 750mm augers were drilled into the ground (rat hole) close to the potential position of the piles.

Whilst the change was being reviewed, Other works continued the project at a different location using 600mm augers. After the design change was approved, the augers were removed from the rat hole and then utilised to install the crane base piles.

The rat hole was not considered as part of the final clean up and demobilization from site.
