LESSONS LEARNED

BLACKFRIARS – RIG MAST CONTACTS CRANE BOOM

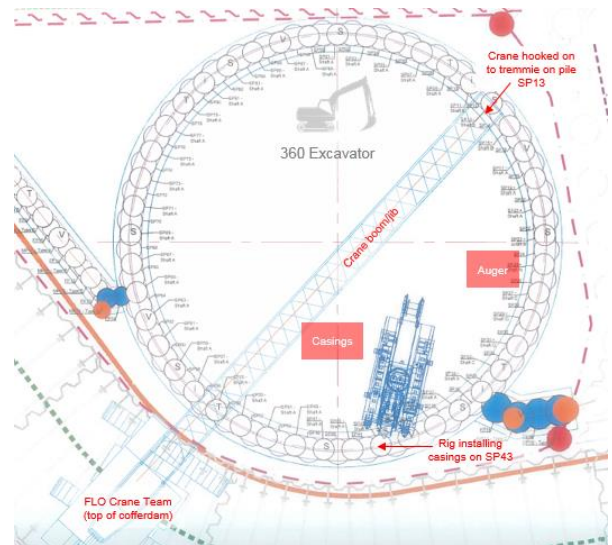
Diagram 1. Cofferdam Layout

On Saturday 11th May 2019, the Expanded piling team and FLO crane team were working in the West Cofferdam. A 250t crawler crane stationed at the top of the cofferdam was hooked on to the tremmie pipe to facilitate concreting works on pile SP13 which required the crane to position the boom straight across the cofferdam (Diagram 1).

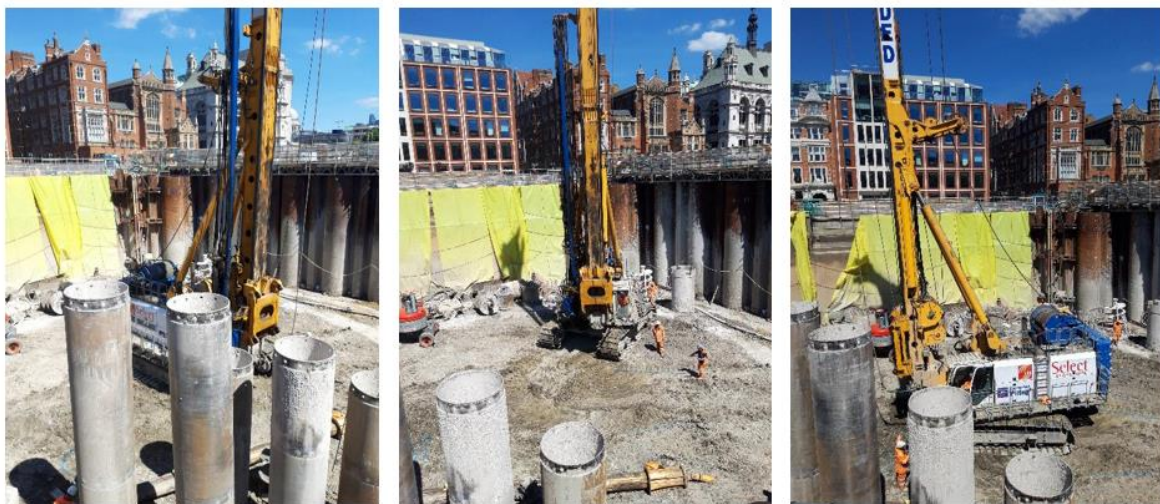
Diagram 2. Rig Movements

The rig slinger signaler (RSS) instructed the rig operator (RO) to track to pick up more casings which were located close to the underside of the crane boom and required the rig to reverse before tracking forward (Diagram 2) to reach the casings. An auger directly behind the rig required the RSS to be stationed towards the rear of the rig during the reversing manoeuvre to clear the auger.

The RSS then instructed the RO to track forwards towards the casings. As the rig is tracking forward, the crane operator (CO) noticed the rig tracking towards the crane boom anticipating the rig mast to make contact with the crane boom.

Rig starting position

→ Rig reversing away from crane boom

→ Rig tracking into crane boom

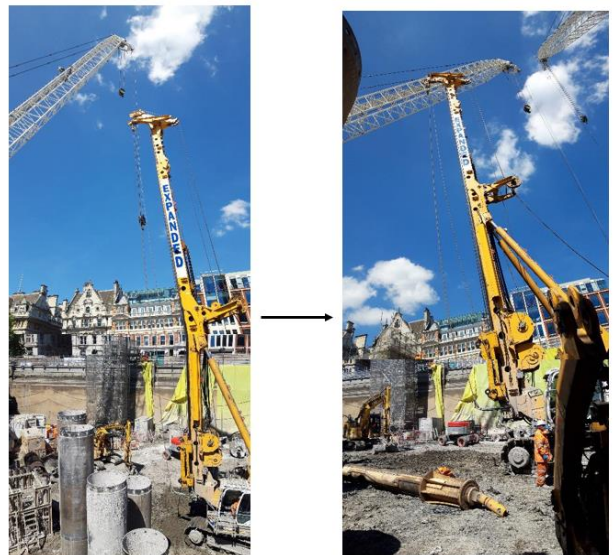
Diagram 3. Rig path tracking into Crane Boom

The CO began sounding his horn and shouting to the team in the cofferdam to draw attention to the anticipated plant contact. The CO caught the attention of others in the area who collectively tried to draw attention to stop the rig tracking forward. The rig team did not hear the alarms or shouting and the rig continued tracking forward at which point the rig mast made contact with the crane boom (Diagram 3), sustaining asset damage to both the crane boom and rig requiring repair (Diagram 4).

- The Rig Slinger Signaller (RSS) did not see the overhead obstruction before instructing the Rig Operator (RO) to track forwards towards the casings (the RSS was positioned towards the rear rather than at the front of the rig when it was tracking forward reducing the ability to anticipate any overhead obstructions)
- The crane boom was in the path of the rig. Plant movements were not planned or communicated, the casings were located close to the underside of the boom, and an auger was positioned behind rig which required the rig to manoeuvre around it
- The crane operator and others in the area were unable to communicate with the RO or RSS to stop the rig tracking forwards and into the crane boom
- The works were not in accordance with the Lift Plan; plant movements were not communicated to personnel/plant and the rig was not issued with a crash radio

- Stop all works in the West & East Cofferdam, crane out of action
- D&A tests conducted (all negative)
- Review, update and re-brief the lift plan, WPPs, VTS' to incorporate risks and controls for plant/plant clash, plant movement & comms
- Issued crash radios to rigs and agreed protocol for use (incl. communicating plant movements)
- Conducted Collective Insight with recommendations informing corrective actions
- Works planning to incorporate diagrams showcasing plant movements, etc. included in the 4pm daily meeting and DAB

- Review/update risk assessments, methods statements and lift plans to ensure the risk of plant/plant clash is identified and the appropriate controls are in place (utilise PvAs as a tool to review planned v actual on site)

- Ensure appropriate forums are in place to plan all plant movements and work activities with all stakeholders (e.g. DAB, black hat meeting, etc.)
- Ensure appropriate measures are in place for controlling all plant movements (for example, ensuring all movements are communicated through the lifting supervisor) and ensure all plant in the work area (e.g. cranes, rigs, excavators, etc.) are considered

- Review the requirement for crash radios in all plant (i.e. rigs, excavators, etc.) as well as cranes per the lift plan
- Ensure key personnel (i.e. lifting supervisors, slinger signallers, etc.) have the appropriate perception tests, appointment letters, authorisation and training
