Health and Safety near miss Haymarket B1

Incident notification

Date and time of incident:	28/02/20 10.30 am	Injury severity:	n/a
Alert Author:	Ken Anderson	Potential severity:	Fatal/catastrophic
HS&W Lead:	Phil Matthews	Investigation Completed:	Full
Operating unit:	Cementation	Operational disturbance:	Struck by object (moving, falling or flying)

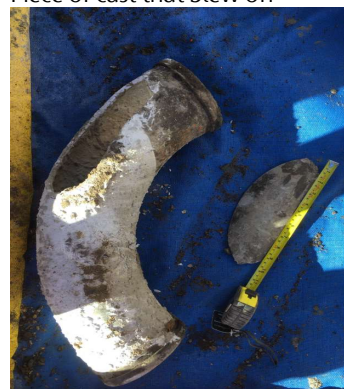
Whilst pumping concrete to P114 a small section of the 90° bend connecting the agitator to the concrete Kleber hose (on the concrete pump) blew off and caused a small amount of concrete to spill on the ground (approx. 1m³ or less). The broken piece of steel hit the nearby concrete skip. No injuries occurred.

The investigation found no obvious reason why the pipe failed. Wall thickness was within tolerance, and there was no sign of impact fatigue. The pipe may have been dropped on it's end creating a weakness.

Piece of cast that blew off

Steel pipe bends will now be specified for CSL as opposed to cast ones

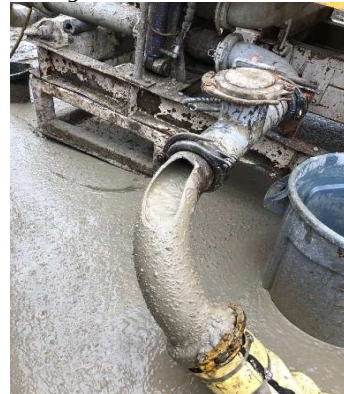
90 degree bend in situ
