HIGH POTENTIAL NEAR MISS RESULTING FROM AN ELECTRICAL FAULT

B A C H A T S A F E T Y A L E R T .

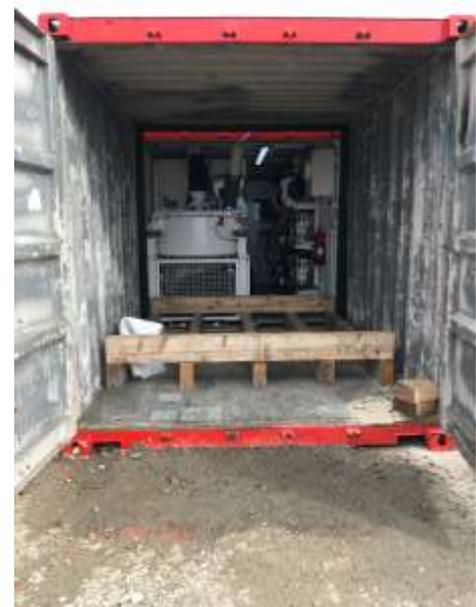
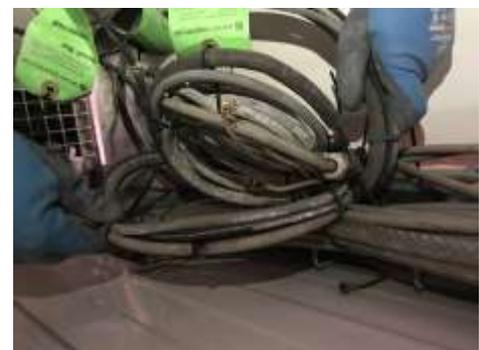
There was a verbal request from a member of the site team for a 2x5 pump to be removed to create more space inside the PRIF container.

- To remove the pump, it had to be unbolted and have the cables removed. These cables become live as soon as the PRIF unit is switched on. When the unit had reached site, the cables were live and dangerous but coiled up in the corner of the PRIF container.
- At some stage, this coil of cables has been moved or pushed, resulting in 2 cores of that cable touching: creating a short circuit and a large flash/bang.
- There has been a serious lapse in concentration or poor judgement that lead to the cables not being correctly isolated and made safe.
- Electrician's SSOW have not been followed.

- Electricians must double check their work before signing it off as complete and safe.
- The process of electricians performing a general inspection of containers/units on site before use is to be looked at.
- Remind all staff about the dangers of Alpha state when performing critical work.
