Safety Memo

Date: 5th October 2020
To: Select Plant, Expanded Geotechnical, FPS
From: Select Plant, Grimsby
Subject: Carden Joint Rubber Buffer Falling Object Incident
REFERENCE NO. SM-05-10-20-117PT

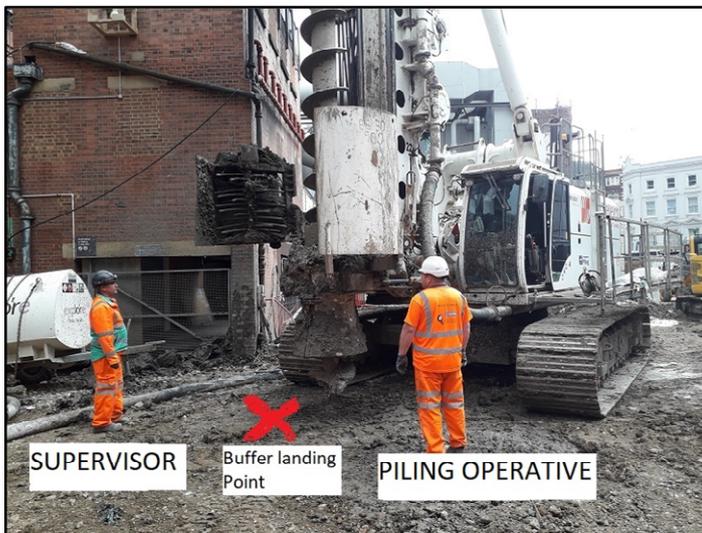
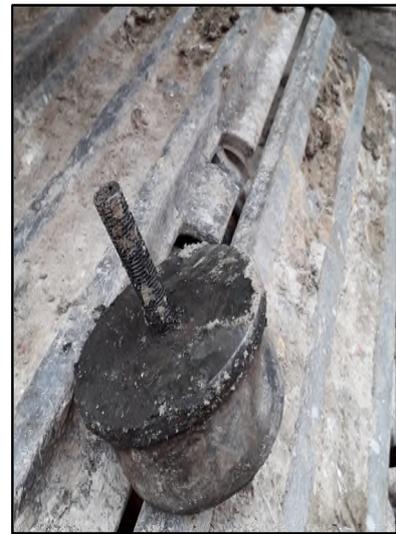
The Expanded Geotechnical team had completed the planned works for the day and were in the process of traveling a Bauer BG30 piling rig to park it up at the end of the shift when a rubber buffer from the carden joint suddenly fell landing approximately 1 metre from where the supervisor was standing.

It is most likely that the rubber buffer had been vibrating loose over a period of time which was not identified during previous servicing as it is extremely difficult to inspect on the daily / weekly inspections, as per manufacturer recommendations. This allowed both the top and bottom buffer to become fully unthreaded and the bottom buffer to fall from height complete with the threaded bar attached.

1. An immediate review of all carden joints across the Select fleet was undertaken to confirm the rubber buffers fitted were securely fixed and in good condition.
2. The carden joint and all non essential items going forward are to be removed for all works where such devices and components are not required. I.e. Carden joint supplied for rotary works only and removed for CFA operations

3. The supply of a clearly demarcated carden joint for 'transport' purposes only. This is to ensure rotary table stability during delivery to site and return from hire.

4. Review of the manufacturers guidance and identification of components that potentially prove difficult to access and inspect during normal site operations. Following this review the maintenance plans on the I Auditor system were then updated.
5. The carden unit and rubber buffers are to be inspected each time the spinner is changed on site with a recorded physical check to be made during the 250hr service.
