SAFETY ALERT

A CASING SPINNER FALLS FROM A MOVING VEHICLE

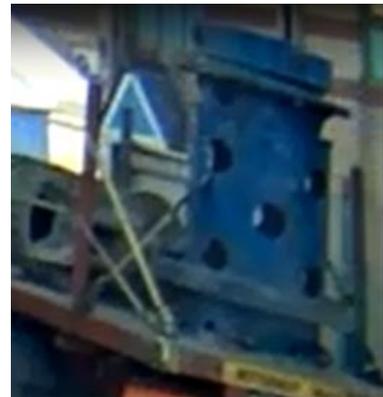
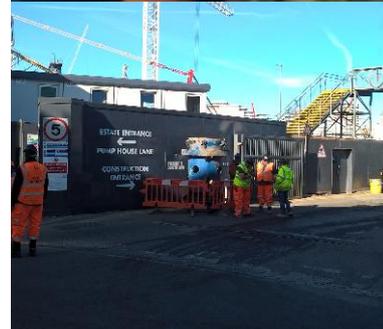
A recent incident occurred, when a spinner loaded on the rear of a trailer became unstable and toppled from the trailer at the site entrance. There were no injuries to anyone on site or members of the public but the load had travelled a significant distance on the public highway.

CRITICAL FACTORS: The spinner was 1m diameter and 1.5m high. Ratchet straps were used to secure the load and hooks were placed in the holes of the spinner body. The straps were used laterally across the vehicle and were fixed to the spinner approximately 1m up.

CONTRIBUTORY FACTORS: The spinner was top heavy and was not placed at the head board to provide additional stability. The speed bump was at an angle on the roadway resulting in the lorry travelling over it one wheel at a time. The lorry and trailer rocked as it passed over the speed bump and the sideways movement was sufficient to allow one strap hook to become detached. As a result the other strap lost tension and the spinner toppled from the trailer.

CCTV footage of vehicle driving in to site and spinner at the site entrance

EVIDENCE OF CHANGE: All spinners will be loaded at the head board of the trailer and chains will be used to secure the load. The chains will be passed through uppermost the holes of the spinner.

All site teams must be briefed on the correct way to load and place a spinner on a trailer

A visual standard will be produced to illustrate how the spinner should be secured to the trailer
