Safety Alert

Near Miss - Hammer detached from rope anchor

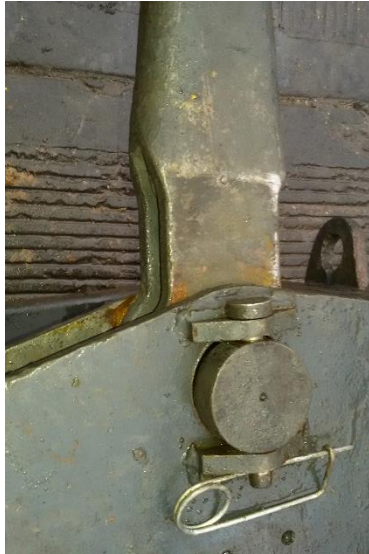
Correctly fitted nappy pin in hammer connection

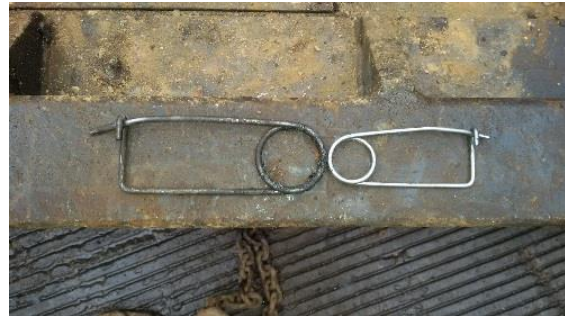
Different size / strength 'nappy pins' used on the hammer/ mast guides. Both show signs of damage and require replacing.

- Manufacturer's information is being reviewed to ascertain the required securing detail.
- Plant Operators to CHECK THEIR MACHINE re the
 - Size and types of pins fitted
 - General condition and tension of springs on the pins

Note – any damage or irregularities to be reported.

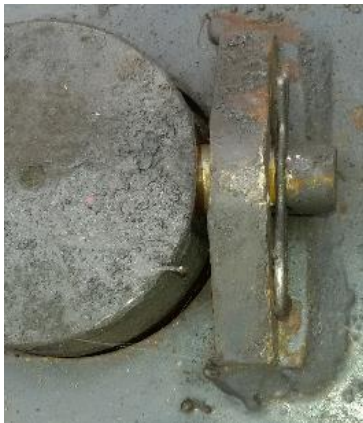
'R' clip securing pin – DO NOT USE!

- There have been NO previous formal reports of nappy pins falling out.
- Nappy pins are preferred over 'R' clips and normal split pins (probably due to the necessity to rig and derig regularly. It was reported we do not use 'R' Clips but another machine was seen with one fitted during the investigation. *(this was replaced)*).

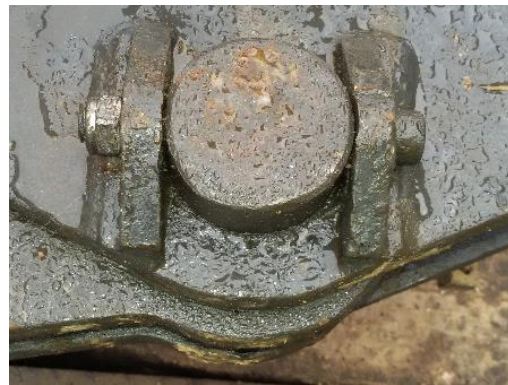
Hi Tensile bolt and nylok nut fitted after event.
