# SAFETY ALERT

## A PILING OPERATIVE IS STRUCK ABOVE THE EYE WITH A PILE CASING BELLY BAND WEDGE

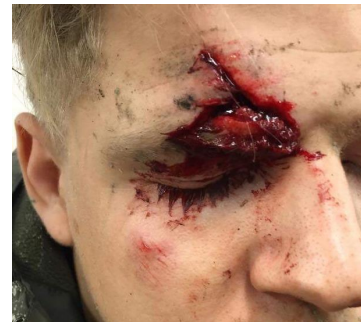
During operations to remove segmental pile casings from a concreted pile, a steel wedge used to trap the casing while extracting from the pile jettisoned from the belly band and struck a piling operative above the eye causing a deep laceration and severe swelling to the face.

Extent of injury above the eye

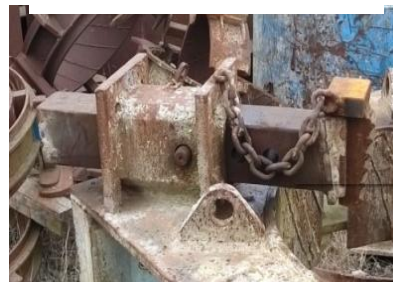
**CRITICAL FACTORS:** The wedges were not restrained in position by a chain or strap as these had been removed. One of the Belly Band legs was not situated on the guide wall when it was set up due to the size of the wall when it was first cast.

Example of belly band wedge with chains

**EVIDENCE OF CHANGE:** A checklist has been produced to check the condition of the Belly prior to use and the maintenance regime has been reinforced. Restraining chains have been refitted to the wedges. A maintenance schedule has been put in place for the segmental casings. A learning note has been produced and the casing extraction procedure has been updated
