## SAFETY ALERT

Falling materials

Near miss

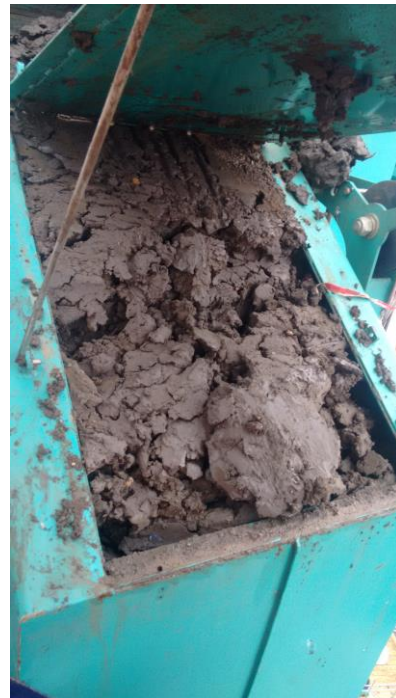
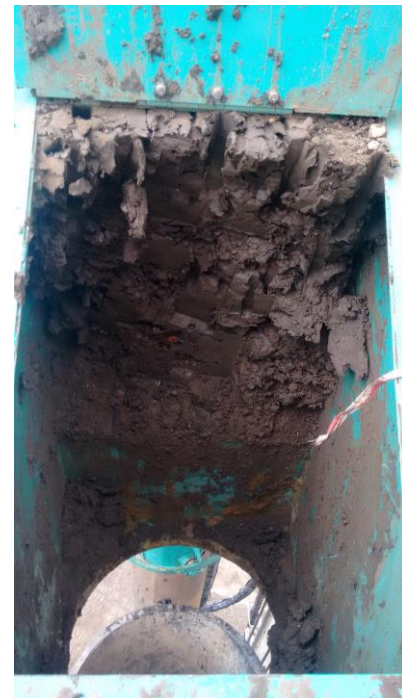
For unknown reasons and whilst drilling female piles, the area of the auger cleaner exit had become blocked and materials could not exit via the chutes.

This is a sealed area without viewing access. The area requires an engineer to open the viewing hatch. Neither the operating manual nor the training provided by the manufacturer shows a need for regular inspections.

The build-up of clay thus did not get noticed.

Immediate cause: build-up of clay and blocked chutes

Visual inspection of top of chutes after each pile to ascertain build-up of clay and shut down to clean when required. FPS safety alert produced to inform others.
