Excavator Hose Failure, Hydraulic Hose Whip.

High Potential (Hi-Po) Near Miss

SAFETY ALERT

Number: 101
Date: 21/05/2018

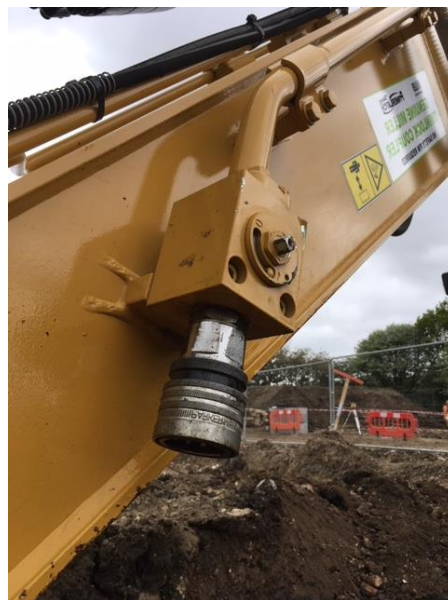
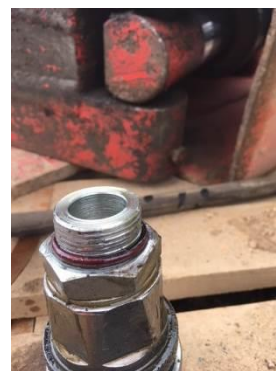
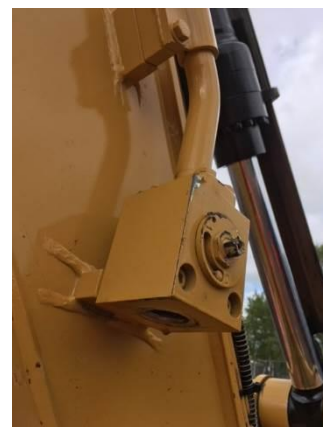
Quick release coupling on a hired excavator broke off under pressure causing hydraulic hose to whip.

- New Excavator (first use on site)
- Carrying out a 'test-cycle' on the cropper.

The exact cause has not been found, the supplier of the excavator has investigated the fault. All that is known is that one of the components has failed, causing damage to the quick release coupling.

- All works stopped immediately, plant switched off and the near miss was reported
- Hire company investigated and carried out the necessary repairs
- Excavator checked over prior to work re-commencing.

- Always ensure operatives are clear of the area when engaging hydraulic pressure to the cropper.
- The 'SAFE ZONE' is outside the zone of influence i.e. where the hose cannot hit or affect someone.
- North East are trialling whip arrestors for the hose connection this week, if shown to improve safety in the event of failure, this will be rolled out as a requirement companywide when using cropping devices.
