Briefing Note

Safe Lifting Operations

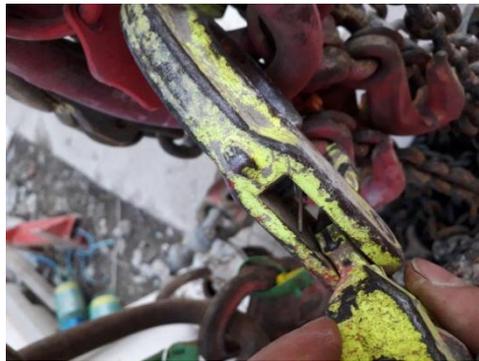
An incident occurred recently at Wood Wharf where a piling cage weighing 1.8Tonnes, 15m long became detached from the crane and fell approximately 7m while it was being lifted from the horizontal to the vertical, fortunately there were no injuries. The subsequent investigation established that there were a number of factors that lead up to the incident.

- The lift plan was not being followed, instead of chains being connected to the lifting band, the plan said shackles should have been used.
- An untrained and inexperienced person was allowed to participate in the slinging of the load
- The chains being used for the lift were not the correct ones, consequently the hooks were too small for the lifting band.
- The chains had been placed incorrectly which caused the load to be applied to the safety catches which failed and released the cage.

To prevent reoccurrence, with immediate effect the following must be followed :

- Crane Supervisors must at regular intervals, check the Lift Plan to ensure all lifts are being carried out in accordance with the plan. These checks to be recorded.
- Only CPCS card holders will be allowed to participate in high risk activities i.e. lifting operations, plant operation etc.
- Where accidents/incidents occur, works must stop immediately and the area must be cordoned off to investigate the event.
- The Expanded Geotechnical Accident / Incident Reporting Protocol must be implemented as soon as practicable after an incident occurs, even if this is “something has happened, details to follow”
- Slingers must ensure that the lifting accessories they are using are the correct ones for the task in hand
