# Health & Safety Incident Report

## >3 Day Ankle Injury, Battersea, BBGE

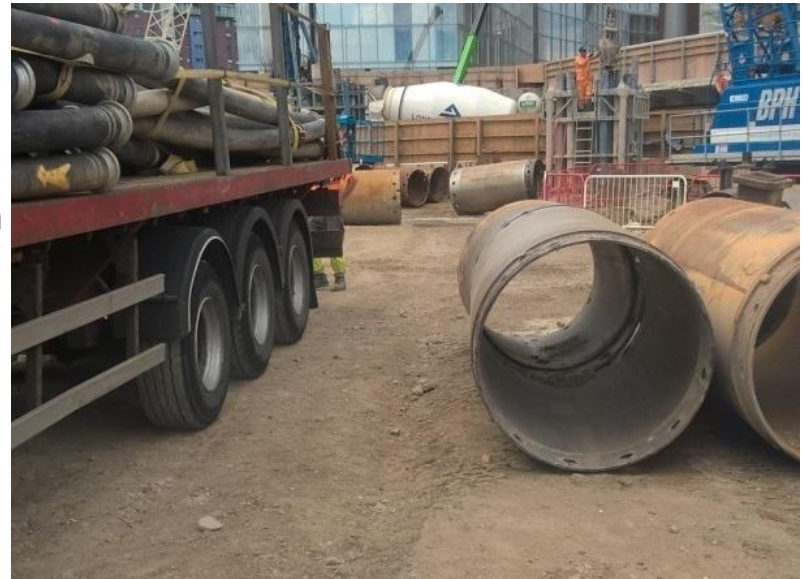
- The injured person was walking along side the lorry while looking up toward the load. His foot stepped into a depression in the ground and he turned his ankle resulting in ligament damage.

- The platform had been previously inspected and no concerns were raised.
- The depression may have been caused by drainage along a concrete barrier that had been there previously

- The platform should be levelled off regularly with ruts and depressions backfilled. Platform condition must be suitable for pedestrians to use, not just plant and vehicles
