Live Auger String

Safety Alert No: 53 Date: 17th September 2018

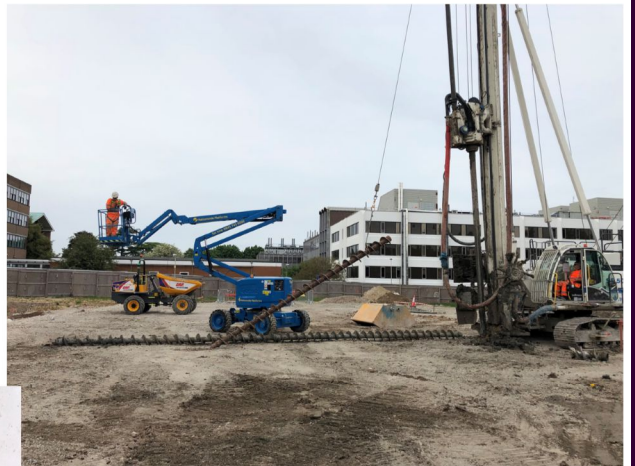
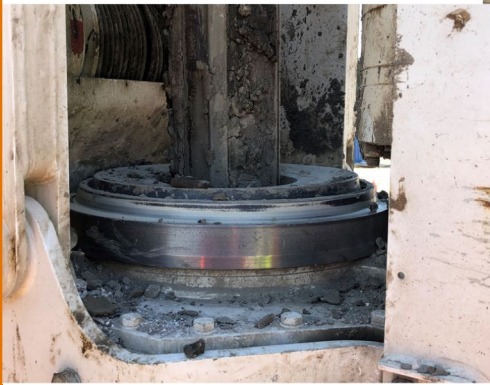
While changing 2 sections of auger flight, the extension bar became unlocked and fell six meters hitting the top off the quill and shearing two auger pins, two 6.0m flights of 350mm diameter auger fell to the ground weighing approx. 1000kg.

The investigation found that the extension bar hadn't been locked in to the keys in the quill correctly, but had been lifted on the edge of the keys.

The problem was the technique of locking the extension bar was done by rig driver's interpretation. There was no electronic aid in the cab.

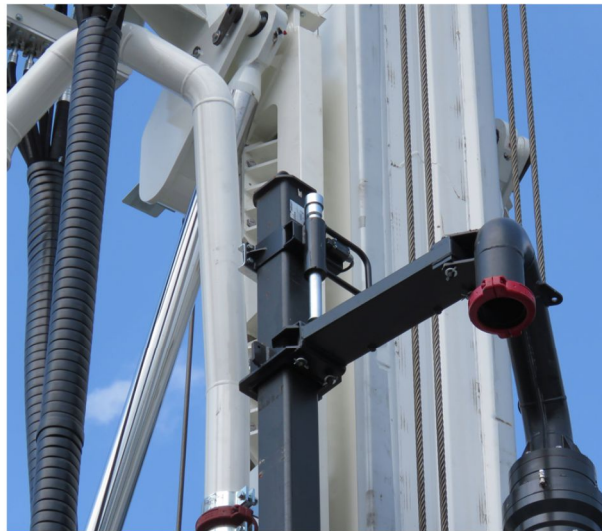
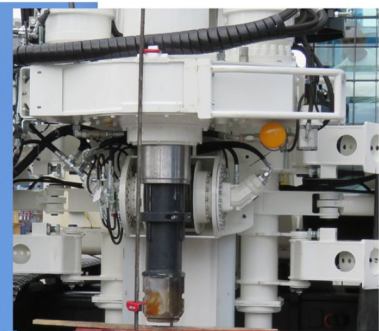
Soilmec Ltd designed a micro switch with a trigger mechanism to be fitted to the reaction bar and a icon on the DMS computer system

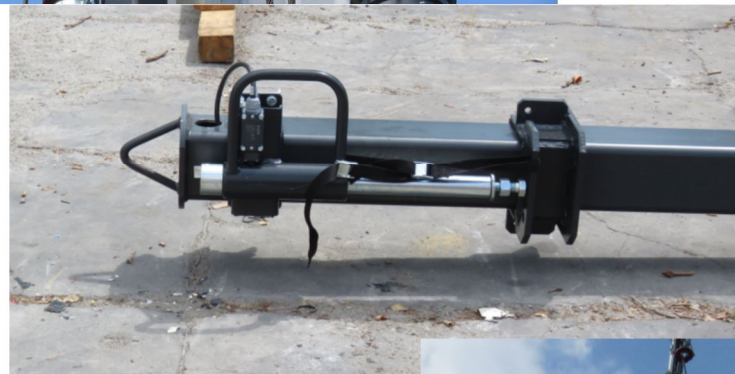
the sleeve is in the correct lower position and the microswitch is triggered

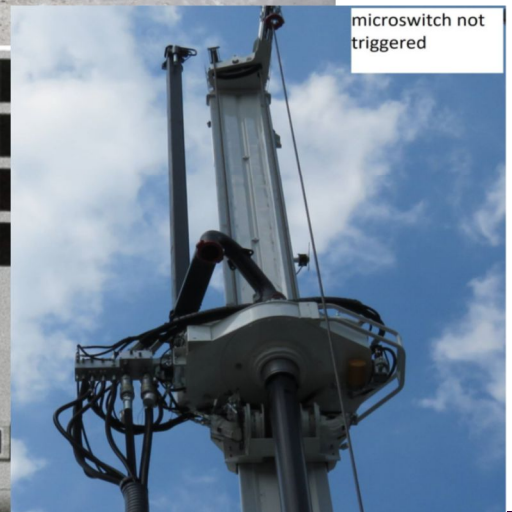
microswitch not triggered
