DAMAGED CRANE HOOK

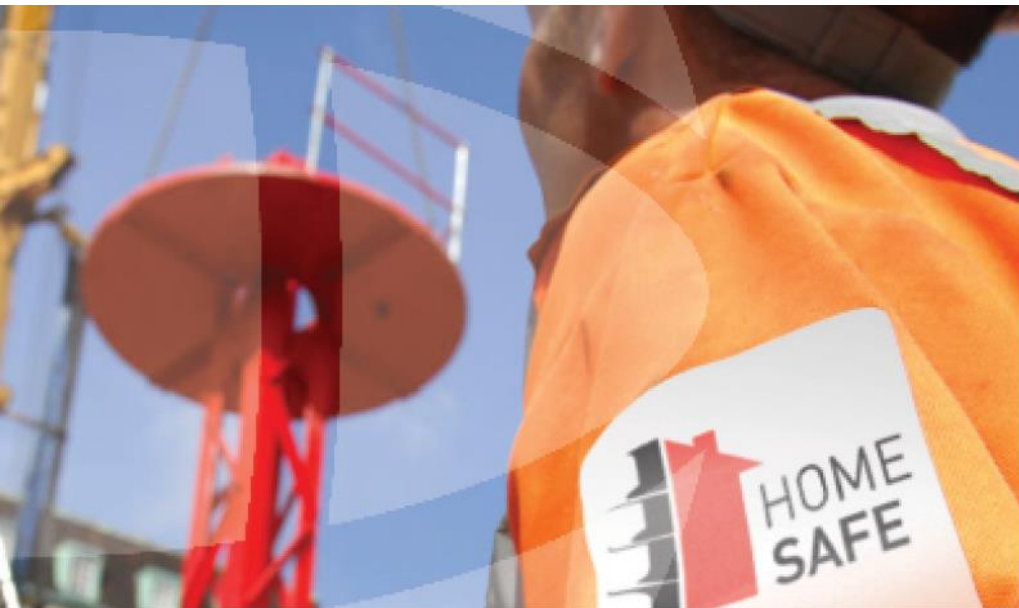
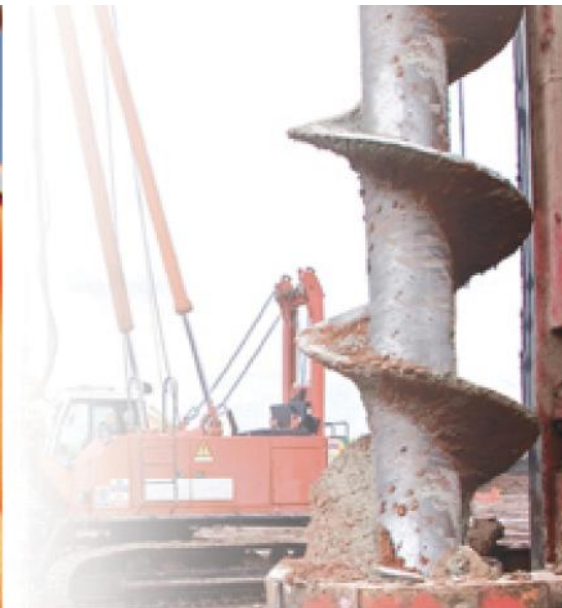
Whilst the mast of a C6 rig was being raised from the horizontal to the vertical position, the swivel that was fitted to the lifting hook detached and fell narrowly missing staff working nearby.

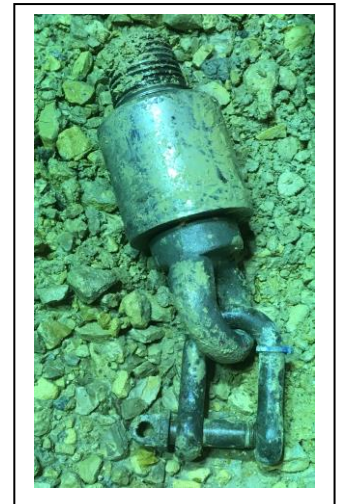
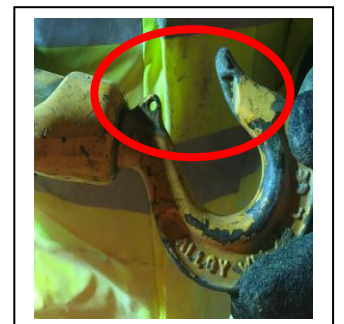
Following the incident, the initial investigation found the spring-loaded safety latch that is **NORMALLY** fitted to the crane hook was not present.

The initial investigation has found that the main likely causes of the safety latch becoming detached are as follows:

- The latch detached just prior to the incident and was not identified by the slingers or rig operator prior to the mast raising.
- Poor operation overloading of the crane leading to excessive strain on the latch causing it to detach.
- The latch was damaged on the previous shift and was not reported / repaired by the team.
- An inadequate pre-use inspection was carried out by the team that did not identify the latch was missing.

- A through pre-use visual inspection is undertaken on **all** lifting equipment to check for damage.
- A through pre-use visual inspection is conducted on all lifting accessories before they are used.
- If faults are present, then this equipment must be quarantined immediately and reported to your supervisor or line manager for repair or removal from the worksite.
- Prior to positioning loads onto the crane hook (during all lifting operations) check the latch is operating correctly.
- Refer to the previous SHEQ campaign or the SHEQ department for further advice.
