HIGH POTENTIAL NEAR MISS UNSECURE TREMIE PIPES

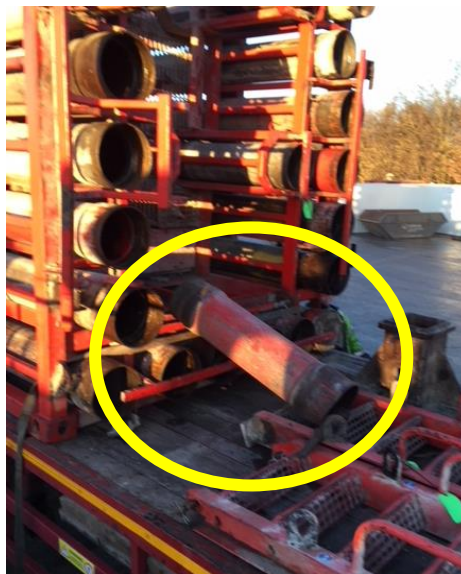
During the offloading of a 4m tremie rack from the back of a wagon it was observed that one of the pipes (1m section) had made its way loose during transport.

Due to the position of the pipe there was the potential for the pipe to fall from the trailer striking another road user or pedestrian leading to fatality, significant injury or damage.

The pipe was re-installed, and the rack was then unloaded pending investigation.

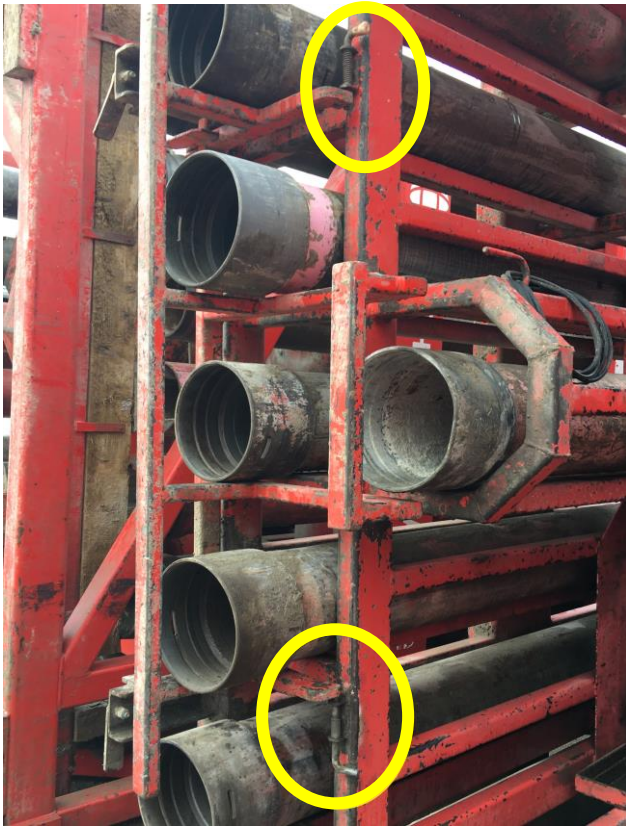
The initial investigation found that the spring-loaded securing pins that lock the tremie pipe securing bar was not present on the rack involved in the near miss (see pictures below).

Tremie rack with the locking pins fitted

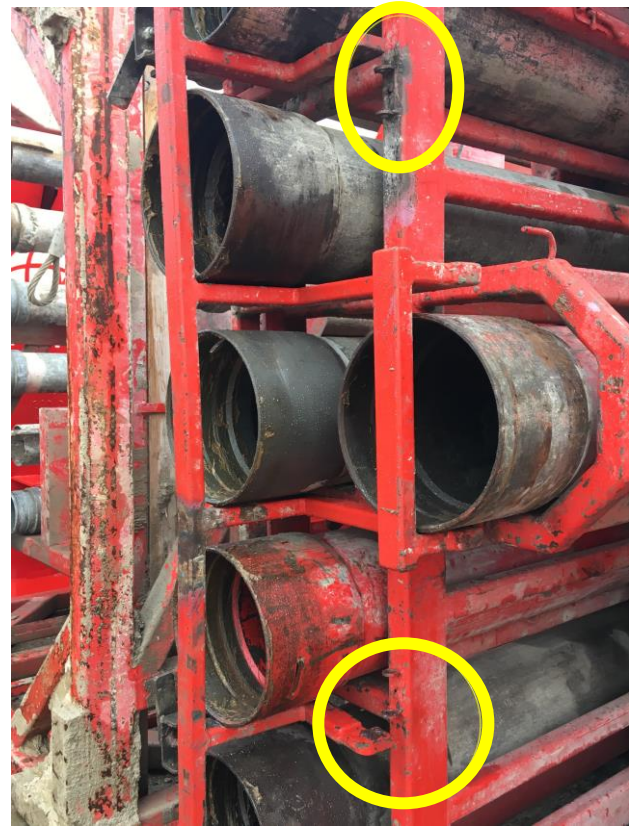
Tremie rack involved in the incident

- Damaged equipment not being correctly reported to the foreman for rectification.
- Inadequate inspection of the rack that should have identified the missing pin.

- A through pre-use visual inspection is undertaken on **all** racks including the condition and operation of the securing pins prior to loading onto vehicles.
- Any visible damage that has the potential to affect the stability or safety of the rack must be reported immediately to the foreman who will arrange for repair.
- A review is being undertaken by the design team regarding a minor modification that will prevent a re-occurrence.
- Refer to the previous SHEQ campaign or the SHEQ department for further advice.
