HI POTENTIAL NEAR MISS WIRE ROPE DETACHING FROM THE CRANE HOOK

B A C H A T S A F E T Y A L E R T .

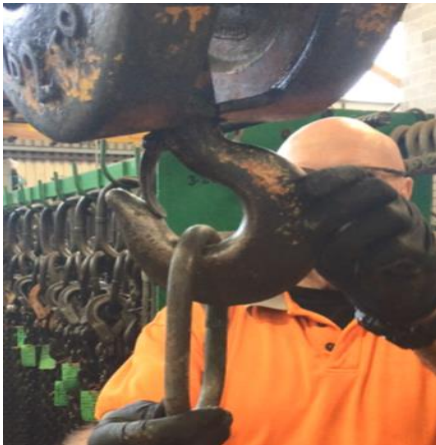
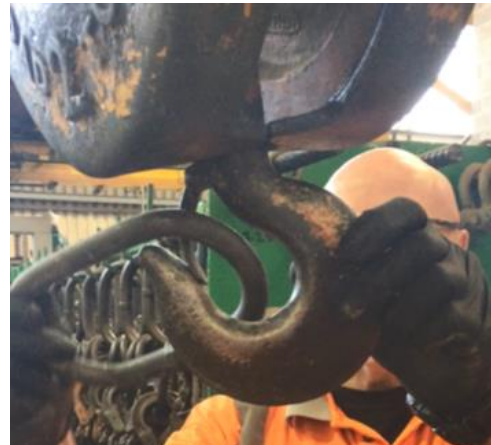
A trial was undertaken in the plant yard to try and understand how this event could have happened and they have proven that it is possible for a lifting accessory to come off the crane hook. See details below.

- The latch became full of grout and stuck open (highly unlikely).
- It is possible the eye has twisted on the hook block, or the block has twisted causing the eye to slide along the hook and force the latch open. This was proven by a trial in the plant yard (See photos below).
- This reality of this situation is this incident can happen to any item of lifting accessory attached to the crane hook.

- A thorough pre-use visual inspection and physical check of the latch is undertaken on **all** crane hooks every time you install new lifting accessories. If any faults are found the crane must be stopped, isolated and repairs undertaken before proceeding.

- Always ensure the lifting accessories including the lifting eye, loop on a webbing sling or thimble is sat in the bottom of the hook before lifting or lowering a load.

- As a precaution, the use of 1m 10t wire ropes to lift tremie hoppers or lifting caps **is no longer permitted**. If you only have these on site to lift tremie hoppers and lifting caps, contact the plant yard immediately to arrange replacement.

- As a company standard, all tremie hoppers and lifting caps can only be lifted using 10t lifting chains c/w lifting ring and kidney links (these will normally be 1.5m in length). The long-term plan is to have these permanently fitted with a “Do not remove tag” installed. Once installed, if you are found removing these items, disciplinary action may be taken against you.
