STOP Think! Moment – A565 NLKC

Damage to 11kV power cable using road pins

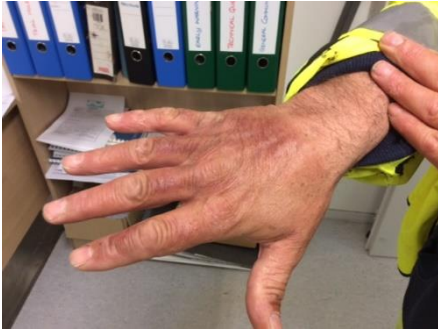
A section of footway had been previously excavated as part of the scheme to widen a carriageway. This involved the installation of new kerbs further into the footway. The subcontractor's engineer was marking out the line of new kerbs using road pins installed using a lump hammer.

During this process, one of the pins pierced an underground 11kV power cable causing it to flash. The engineer was caught in the flash and received minor burns to his hand, face and torso. His clothes and PPE were also burned. He went to hospital immediately to be checked. He returned to site later that day and was fit to work the following day.

- ✓ The use of metal road pins creates a significant risk.
They are not to be used on Osborne projects. This BAN is with IMMEDIATE effect.
- ✓ **Flame and arc flash resistant clothing MUST be worn when breaking ground.**

If you need assistance sourcing an alternative to metal road pins, please contact a member of the SHE team.

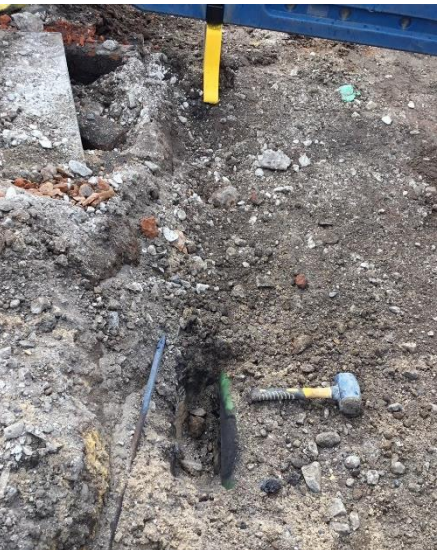
- Minor burns to the engineer's hand, face and torso. This could have been significantly worse.
- Damage to the cable with some short term power loss to local businesses.
