RED BRIEF

Genie MEWP manufacturing defect

| | Safety Notice Mandatory Action Required | 200007 | Genie A TEREX BRAND |

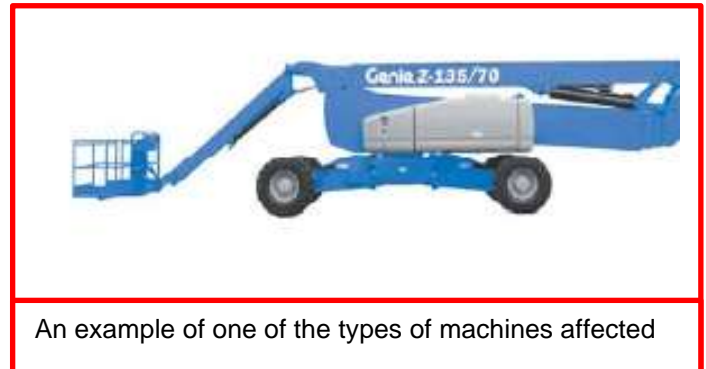
Genie has determined that the secondary boom lift cylinder installed on the above referenced machines, may develop cracks between the hardline and barrel. The cracks may propagate causing an oil leak. **An oil leak can lead to machine instability resulting in a machine tip over.**

Action(s) Required:

- Inspection of the cylinder transfer tube type to determine if the cylinder installed in your machine is affected.
- Inspection for leaks and/or crack in the weld seam of the affected cylinder..
- Replacement of the affected cylinders that show signs of leakage or cracking.

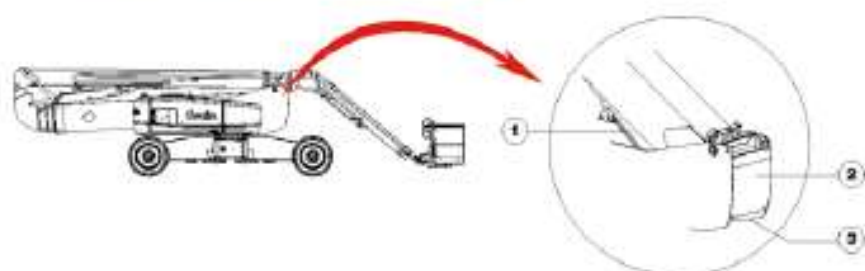
- 2 Locate the Secondary Boom Lift Cylinder.

- 1 Secondary boom lift cylinder
- 2 Upper swing cover
- 3 Lower swing cover

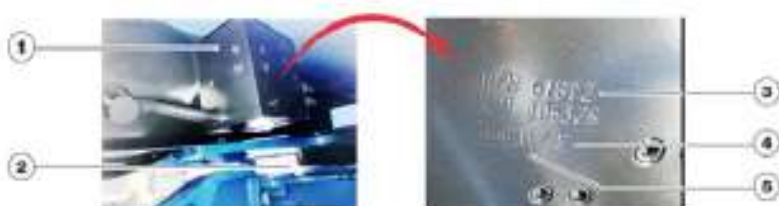
- 3 Locate the manifold and record the cylinder serial number stamping.

- 1 Manifold
- 2 Turntable
- 3 Cylinder Part Number (61812)
- 4 Revision Level (Rev E shown)
- 5 Cylinder Serial Number (D9E017 shown)

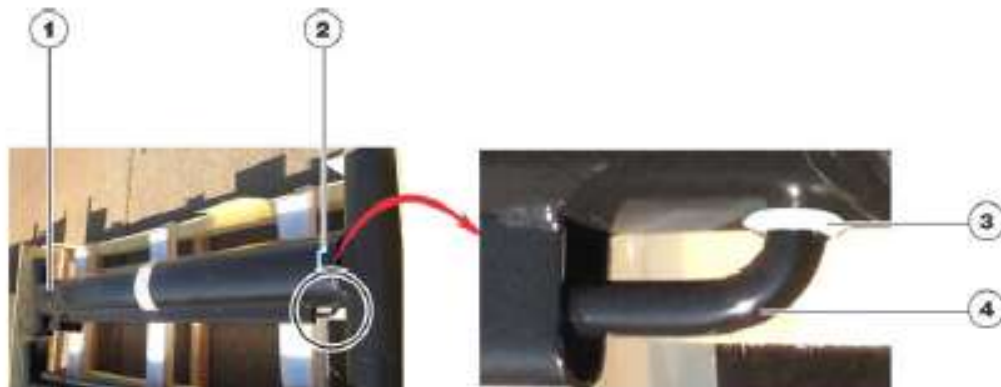
- 1 Start the engine from the ground controls and raise the secondary boom above the turntable covers.
- 2 Push in the ground controls red Emergency Stop button to the off position.
- 3 Remove the upper and lower swing covers at the pivot end of the secondary boom and set aside.
- 4 Locate the Secondary Boom Lift Cylinder.
- 5 Inspect for leaks around the weld seam between the transfer tube and the barrel as indicated below.

Keep away from leaks and pin holes. Use a piece of cardboard or paper to search for leaks.

- 1 Manifold end
- 2 Barrel end
- 3 Weld seam
- 4 Transfer tube

⊗ **If oil leak is observed**, the cylinder needs to be replaced.

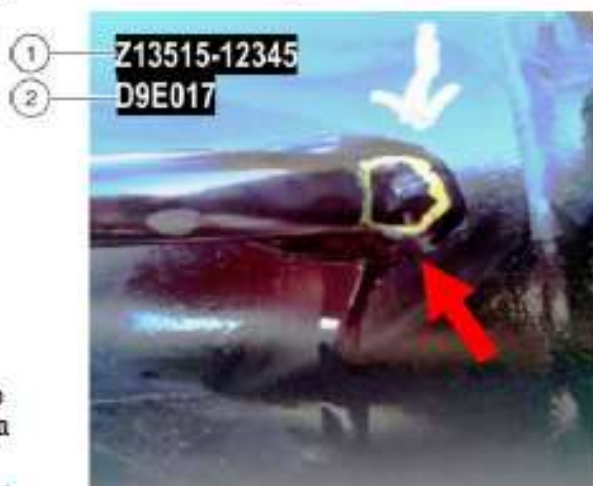
Note: Include the machine serial number and cylinder serial number on the photograph. The form will not be processed without this information on the photograph. Warranty claims for cylinder replacement must be filed under **Safety Notice 200007**.

- 1 Machine Serial Number
- 2 Cylinder Serial Number

- a Take a photograph showing the leak.
- b Remove the machine from service.

- c Fill out the attached 'Completion Form for Inspection for Leaks and/or Cracks' or file a warranty claim for **Safety Notice 200007_1** to verify that inspection for leaks have been completed.
- d Fill out the attached Parts Order Form and return to Genie with the photograph showing the leak to receive a replacement cylinder.

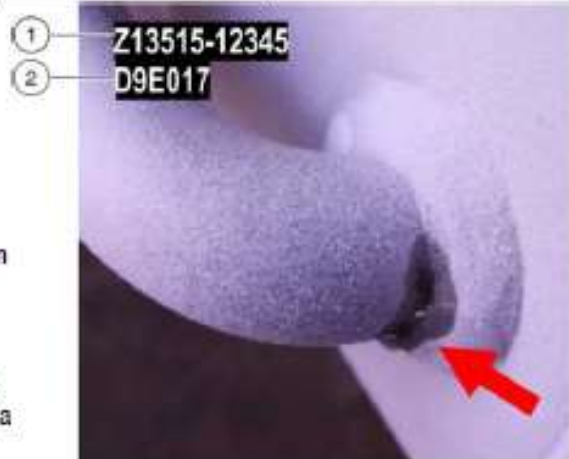
- Machine Serial Number
- Cylinder Serial Number

Note: Include the machine serial number and cylinder serial number on the photograph. The form will not be processed without this information on the photograph. Warranty claims for cylinder replacement must be filed under **Safety Notice 200007**.

- ⊗ If any crack is found, the cylinder needs to be replaced.

- Take a photograph showing the crack.
- Remove the machine from service.

- Fill out the attached "Completion Form for Inspection for Leaks and/or Cracks" or file a warranty claim for **Safety Notice 200007_1** to verify that inspections for leaks and cracks have been completed.
- Fill out the attached Parts Order Form and return to Genie with the photograph showing the crack to receive a replacement cylinder.
