Health and Safety near miss Kensington Odeon

Incident notification

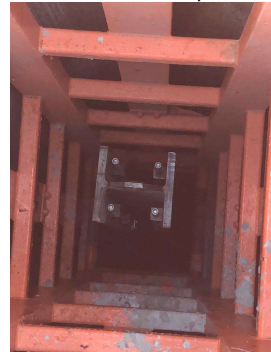
A pile bore had been concreted the previous day as per the design, to support a plunge column, where concreting had finished at 3pm. An operative was removing the elbow brackets following the standard process. The first bracket was released and removed. While removing the last bolt on the second bracket it was sticking so he tapped it with a hammer. The plunge column dropped into the pile taking the bracket with it. The concrete had not set. There were no injuries.

The root cause of the incident was the inadequate quality of the concrete mix. The additives overextended the workability of the concrete. There was no back up method in place to check that the concrete was fully set and could support the column.

Column sank into pile bore

A sample of concrete shall be kept on site in a cube mould/bucket and checked to ensure concrete has set before removing plunge column.

A set of cubes shall be taken and cubes will be broken at the following days 7, 28, 28 and spare with an additional 2 cubes left to be broken the following shift in the morning and another broken at midday to ensure the concrete has reached adequate strength before removing the supports for the column.
