BAC CHAT SAFETY ALERT.

HI-POTENTIAL NEAR MISS CONCRETE HOSE CLAMP FALLING FROM A MEWP NARROWLY MISSING AN OPERATIVE BELOW

Issue number – 147
Date of issue – 12/08/19

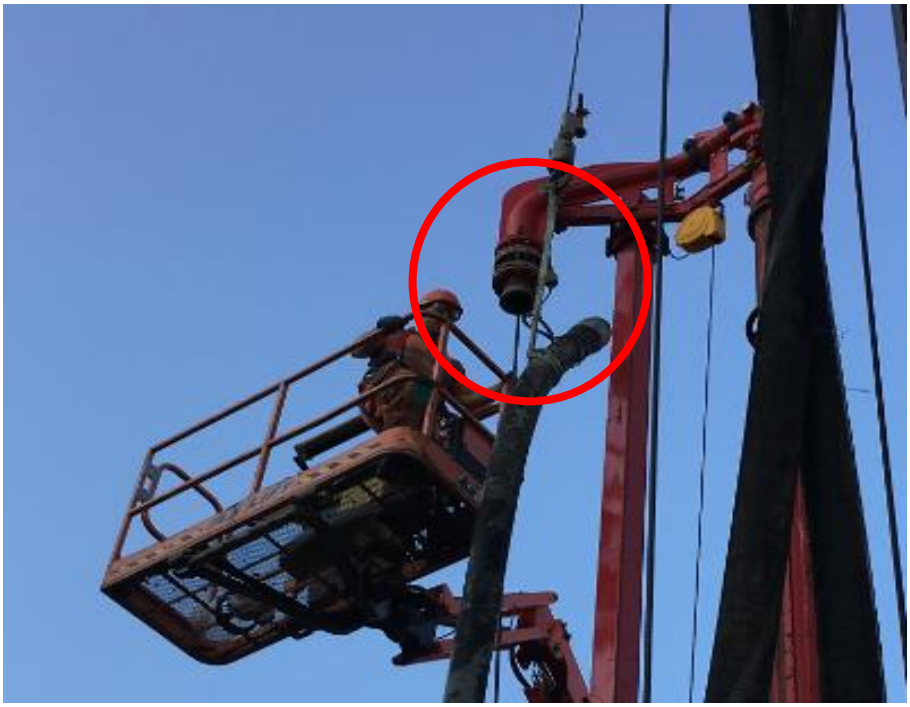
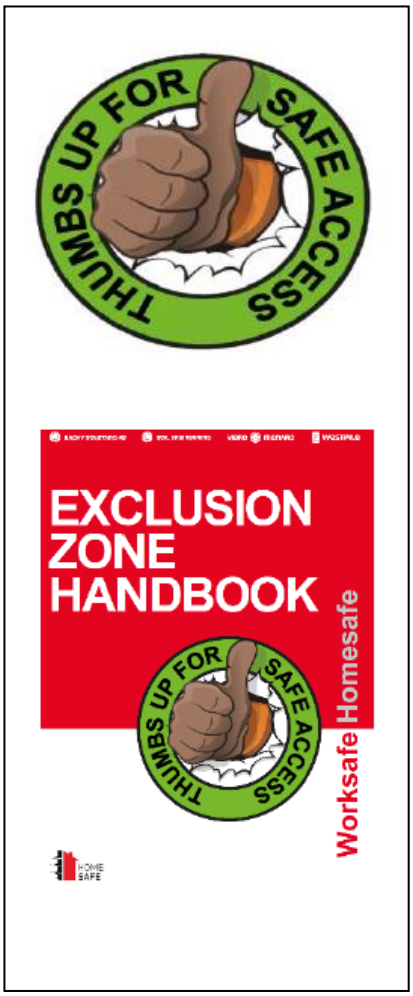
After successfully clearing a concrete blockage in the Casagrande B200XP hanging pipe, one of the BSL operatives attempted to re-connect the hanging pipe to swan neck (site operative working from MEWP).

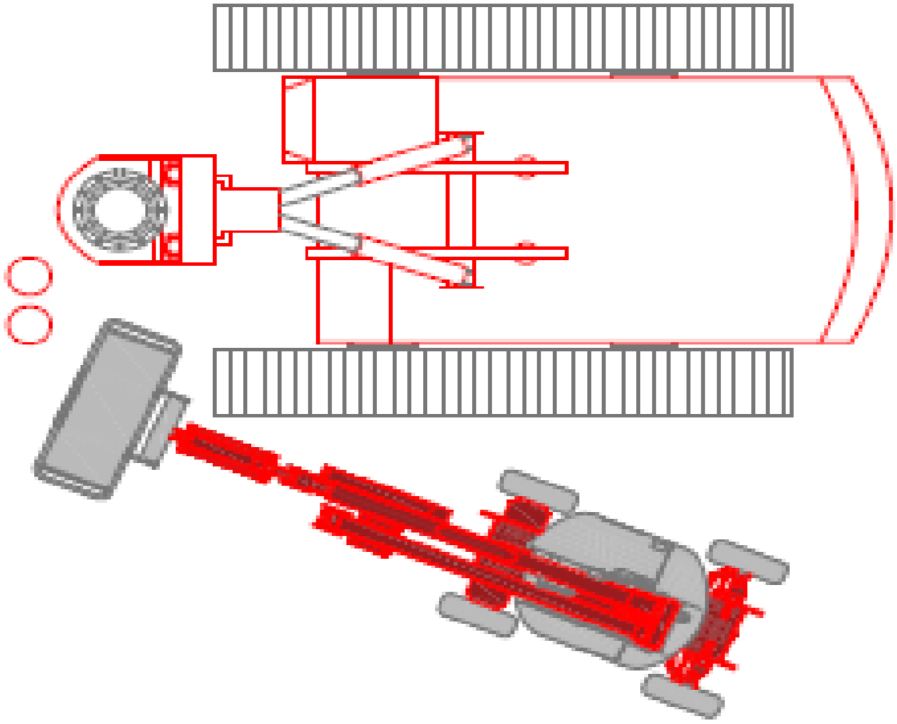
Whilst attempting to complete this operation a concrete pipe clamp fell from the MEWP basket that was about 6m abgl narrowly missing another site operative who was standing near the MEWP on ground level (circled below).

- It has become apparent that the process of fitting the hose and fitting the clamp can be very difficult for one person to undertake on their own as they must locate the hose and fit the clamp at the same time.
- Due to the numbers on site and the location of the MEWP basket in relation to the hanging hose it is not always practical to have 2 x people in the basket. A person must always remain on the ground to assist in emergency lowering if required.
- The procedures around exclusion zones could not be followed as the operative on the ground is assisting in locating the hose meaning that this operation can result in a fail to danger and not fail to safe.
- The feedback and internal communication on this issue was generally poor. Following this incident various people have said this can happen quite easily but this has never been clearly communicated.

- All staff involved in securing hanging hoses, especially, ground based staff are always to remain vigilant in the short term and always adopt the hierarchical principles to managing risk when entering exclusion zones.
