HI-POTENTIAL NEAR MISS FALL HAZARD FROM AN OPEN BORE HOLE

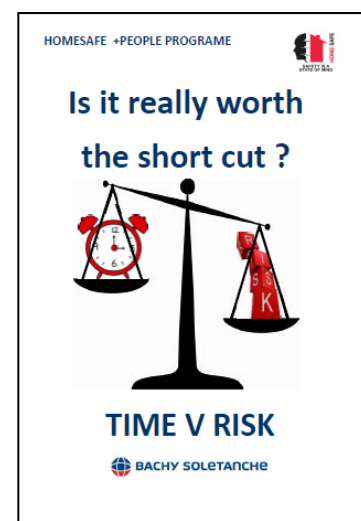
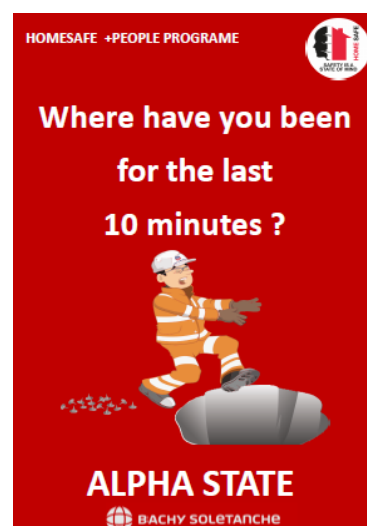
On the 01/04/19 the client reported that whilst the groundworker was conducting clearing works they uncovered an open bore that was approximately 750mm wide X 8.5m deep. Fortunately, nobody was injured as a result of this near miss, and the area was cordoned off making it safe.

- When the 750mm auger was removed from the rat hole, one of the crane base positions was close by, it is likely the arisings from this position covered the rat hole.

- The CFA RAMS will be reviewed and include a section on drilling and backfilling rat holes.
- Once daily works have been completed the site teams are to ensure a thorough review of the works area is undertaken that includes a final visual check of any previous installed positions / rat holes to ensure they have been suitably backfilled, marked up or barriered off.
- Consideration should be given to ensure that rat holes are located within the piling platform / approved permit to dig area.
- Rat holes must be drilled at least 4 x width away from the pile position if they can't be drilled into the final position.
- Pile arisings next to pile positions should be cleared before we demobilize and leave site.
- Before appointing subcontract agency staff, we must ensure that provisions have been made for language barriers.
- Consider what currencies are present when undertaking your work.
