## ***SAFETY ALERT***

Struck by Moving Part

Fractured Hand

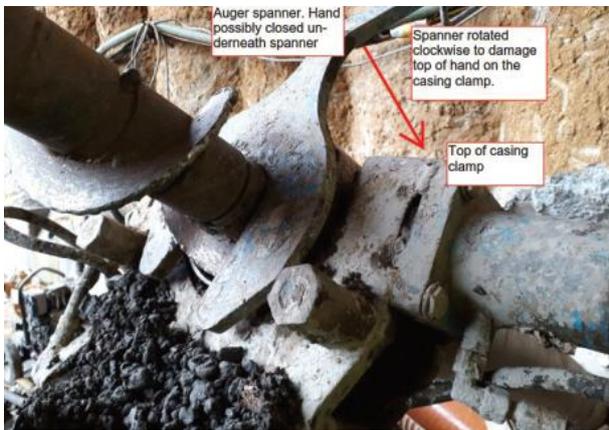
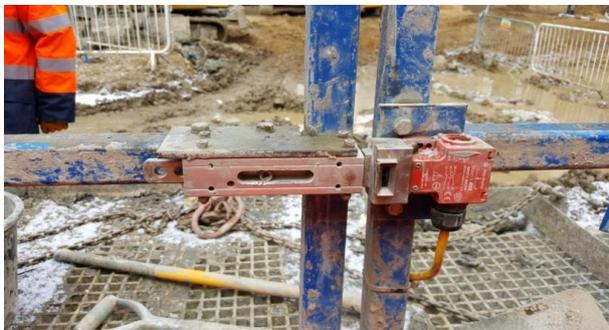
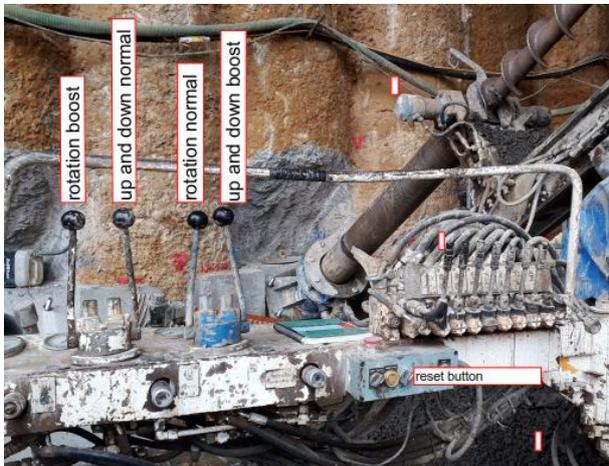
During anchor installation works an operative injured his hand between the spanner and the clamps in the process of adding additional augers. The injured person was assessed at hospital and found to have non-displaced fractures to two metacarpals in his right hand and a cut on the soft tissue between his thumb and fore finger. He returned to site with soft plaster strappings and was taken home at the end of the day. The accident happened during/after the installation of the final auger. It was necessary to pull back the final auger that had been placed on the string to release the auger spanner from the top of the casing in order to continue drilling to depth. The spanner man had his hand under the auger spanner handle which was facing down (not up which would have cleared the clamp shelf) and was expecting the auger to be raised as the rig operator has pulled the wrong lever. The spanner is shaped with the handle formed at an angle to the horizontal to ease manual handling and facilitate easy lifting. Instead the auger rotated clockwise at speed with the spanner man's hand attached to the spanner and this rotation caused the spanner to rotate clockwise and his hand hit the auger clamp.

A defective safety interlock on an access gate to the podium, that was not reported, resulted in the site operative bypassing the safe access steps and gate

Work was stopped and not restarted until all safety devices had been inspected and confirmed as working correctly.  
All machines were inspected by the plant technicians to confirm that they were fit for use.  
All operatives were re briefed to ensure that they were fully aware of the safe working practices and how safety devices are used.  
Disciplinary action was taken against all operatives involved in the improper and unsafe use of equipment and for the continued use of defective

equipment without reporting it to site management  
A warning light system was installed on the podium to visually confirm when safety devices are inactive/active  
Briefing records and plant / equipment check sheets were and continue to be reviewed both on and off site to ensure that they are completed

If equipment is modified for a specific contract then the pre-use checklists should be amended to reflect the modifications  
Not all rigs and podiums were compatible with each other and although this was known by the site teams, it was not communicated to management. This resulted in some devices being inoperable. All equipment is now interchangeable  
Operators and rig attendants were trained on the daily and weekly check requirements but supervisors must confirm that the learning is embedded  
Management must confirm that daily and weekly inspections are being carried out and records are being correctly maintained
